If it didn't fit...lead it!

by John Spinks

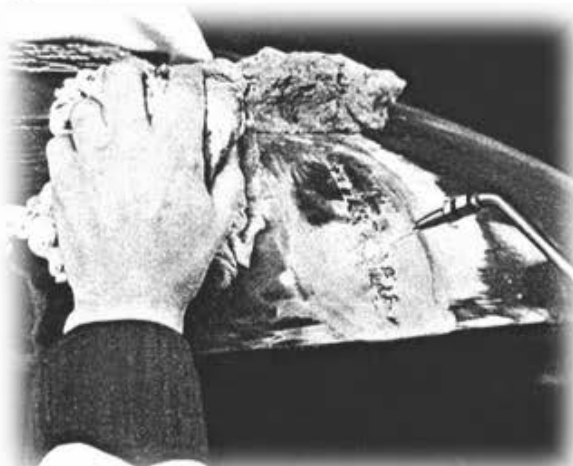
Condition of the Airflow body panels under the lead is an absolute maze of pimple dents and very crude welding by today's standards and it appears that Chrysler body builders made them to a rough shape and crafted everything in lead

Even the remnants of the fuel filler pipe opening in the left rear of the body is still evident under the lead and this has been welded up as the '36 filler is located into the left rear fender. The same can be said for them also welding up the body extensions that appeared on the '34 bodies to bolt the rear bumpers to. On the '36 and the '35's the rear bumpers bolted to a bracket that looped off the chassis and down under the rear of the body so these extensions were therefore redundant on these models.

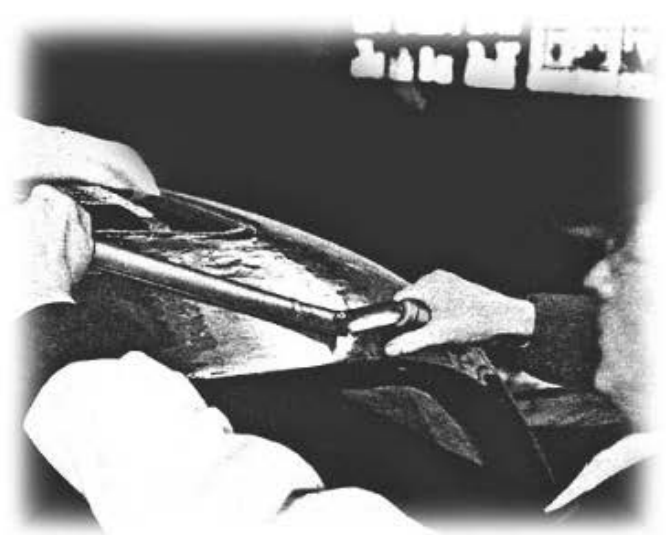
Filing the body smooth
