## Some Airflow Manuals Are In Error... by John Spinks

This information may save some members from serious damage to certain Airflow models based on incorrect information printed in certain early factory maintenance manuals. Some very expensive damage can occur if the original directions are followed.

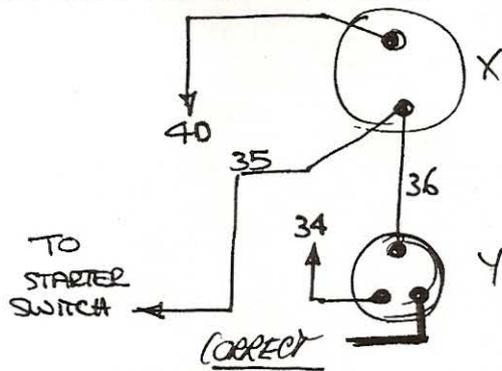
The service standards for models C9, C10, C11 in "Group 15", page C 3-11, refers to wiring diagram illustration number C9 - 7A26 and C10 - 7A27. Refer to wiring diagram illustration C9 - 7A26 and you find: CC= starter switch; X= fuel gauge panel unit; Y= ignition switch & lock. Wire 35 connects the starter switch to the terminal on the fuel gauge with wire 40. Wire 36 connects the ignition switch to the fuel gauge.

If you wire your Airflow per this configuration a disaster will occur. The moment the starter switch is depressed, the solenoid will draw many amperes through the very sensitive movement of the fuel gauge thereby burning out the gauge immediately! The **REMEDY** is this: Wire 35 should connect to wire 36 at the terminal on the fuel gauge. Only one wire should connect the other terminal - that is #40.

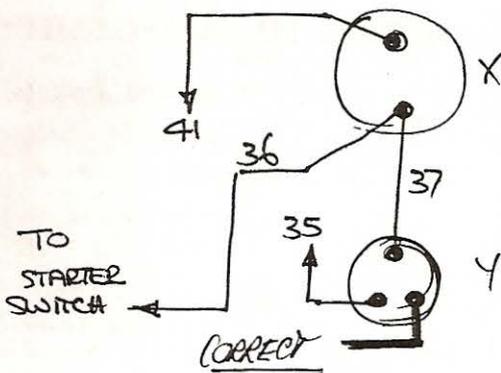
A third error centers on illustration C10 - 7A27. DD= starter switch; X= Fuel gauge panel unit; Y= ignition switch & lock. The diagram is incorrect as printed therein. The **REMEDY** is: Wire 35 should connect to wire 37 at the terminal on the fuel gauge. Only one wire should be connected to the other terminal - that is #41.
