## AIRFLOW OVERDRIVE LEAK

by John Smith

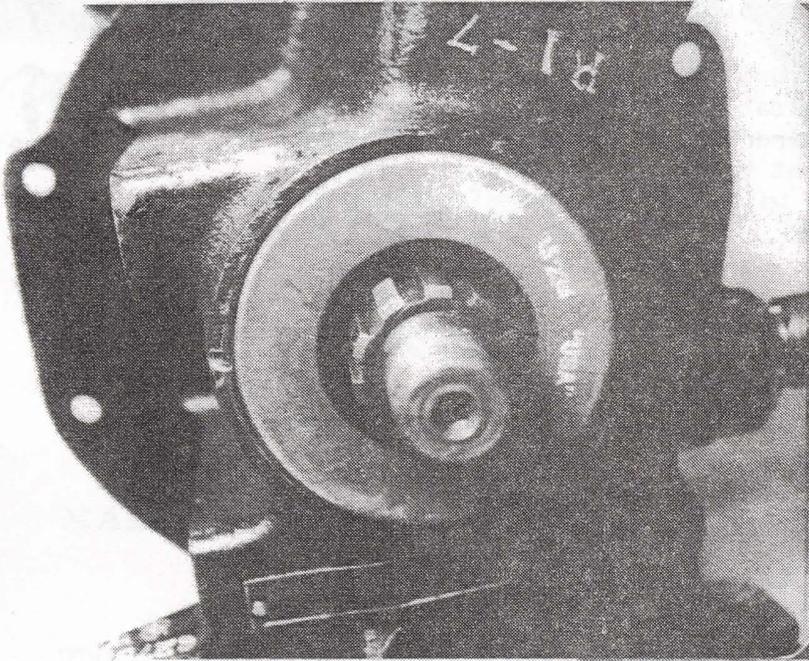
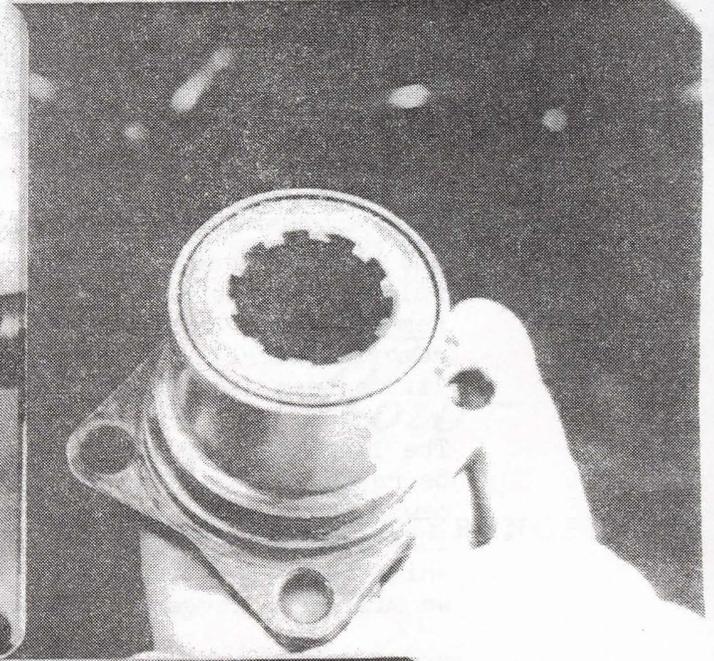
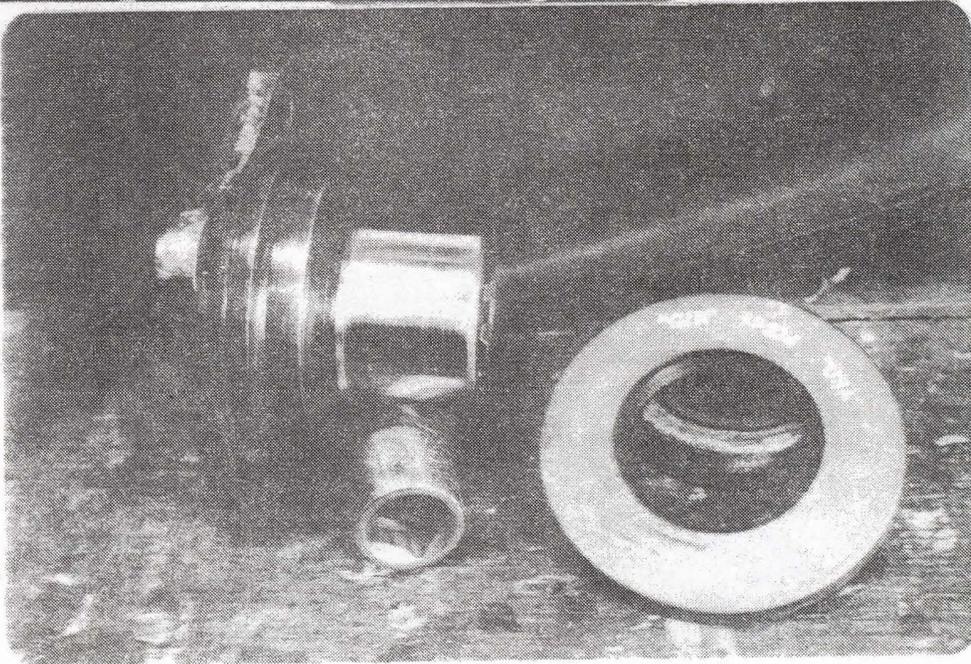
We tried to photograph each of the yokes after all work was complete and enclose a photo to try and give you a good look at what we think is one solution to the leak problem.

You can find a (Chicago-Rawhide) seal that fits the opening in the rear case half with no problem. That opening is 2.835 in size. If you have a yoke that has an outside diameter of 1.564 or close to that, then you can have the outside cut down to 1.554 or 1.553 and polished-then a seal NO CR 15234 or a National No. 471915 will fit and stop all your leaks.

If you have the large yoke then its a bit more difficult. The yoke must have a sleeve pressed over it and the diameter cut and polished to measure 2.002 or 2.003

We found an old Plymouth drive shaft that measured 2.000 was still satisfactory- we cut a two inch piece and cut about one half the skin thickness out and then pressed it over the yoke and this expanded it somewhat. It then measured 2. plus twenty five thousandths- which gave sufficient to cut and polish to the desired 2.003 We then purchased a seal number CR 19848 for \$3.12 and it worked like gangbusters. This seal is almost one half inch thick-so will fill the space alrite. 4
