In 1962 we had a serious problem with the centre section of our CV exhaust manifold which buckled and cracked beyond repair due to excessive local heating down behind the intake manifold. We thought that the story of how we solved the problem may be of interest to members.

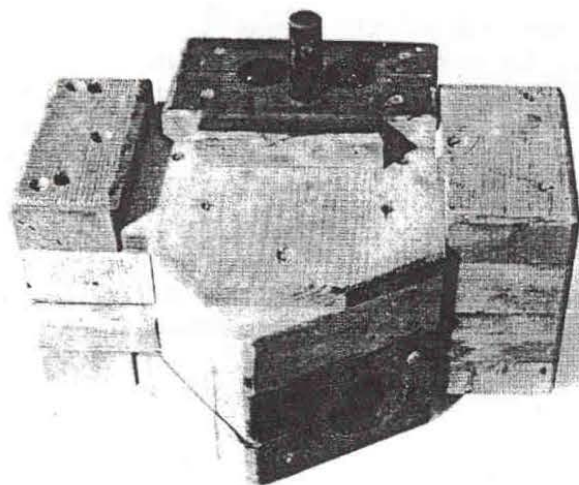
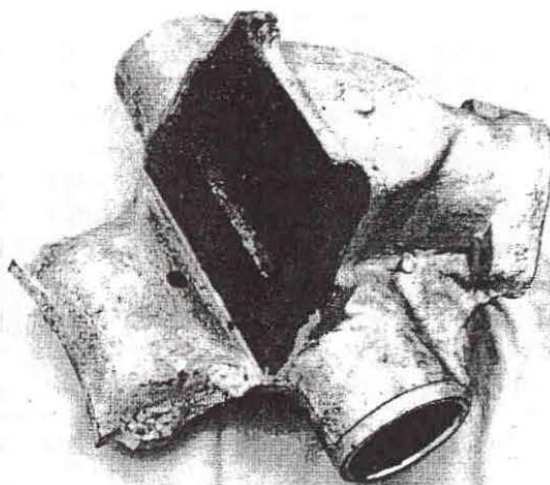
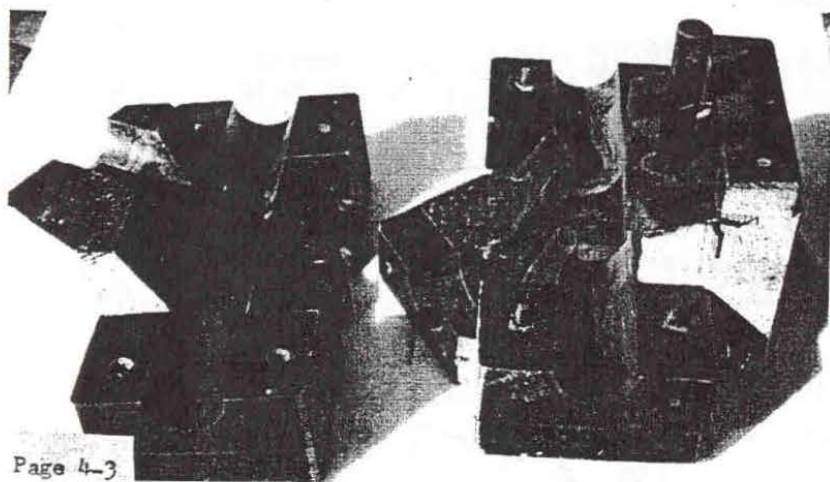
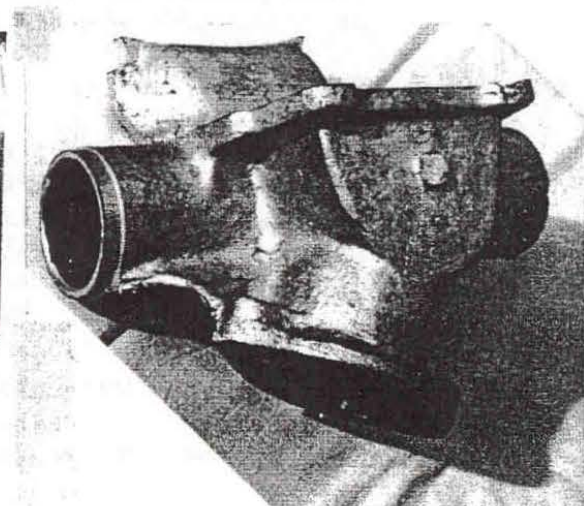
As the original section was beyond repair the only other hope was to have new ones made, so we searched around for a pattern maker. Eventually we found the right man, prepared to accept the challenge and who, in a few weeks, supplied us with the pattern as shown in the photos. Next problem .. where could we get the castings made? Here again our good samaritan came to the rescue. He offered to approach his friend, an engineer in charge of an industry which included making castings for railway rolling stock who obliged us by having three castings made. Being of cast steel these will no doubt serve better than cast iron. Then came the problem of machining the castings to match the end sections of manifold perfectly. We had one machined where the

castings were made, but this was not successful. Then my mate and I, during the course of our work, called in to the local University, where we had a talk with the maintenance machinist in the Automotive workshop and the Uni Automotive teacher. They, too, were ready to accept the challenge. I supplied end sections of manifold and a template of the exhaust and inlet ports and studs, and in due course we had two new centre sections, machined perfectly. The ends fitted perfectly, and the castings fitted flush with the block. This project saved the Airflow's life as, without the centre section it would have been grounded. I only had one CV and one CU at the time and both sections on each car were cracked. Guess we were lucky to meet the right people interested enough to help keep the Airflows flowing.

Must mention that, at this time, the Airflow was my only means of transport and, in order to get it back on the road as quickly as possible we didn't go to the trouble of re-fitting the thermostat operated heat deflector vane. The only sad part of the whole affair was that the pattern maker, without whose help we would not have made first base died before he was able to see the finished unit.
