TECHNICAL *Tips*

S-2 Dashboard Paint or Woodgrain?

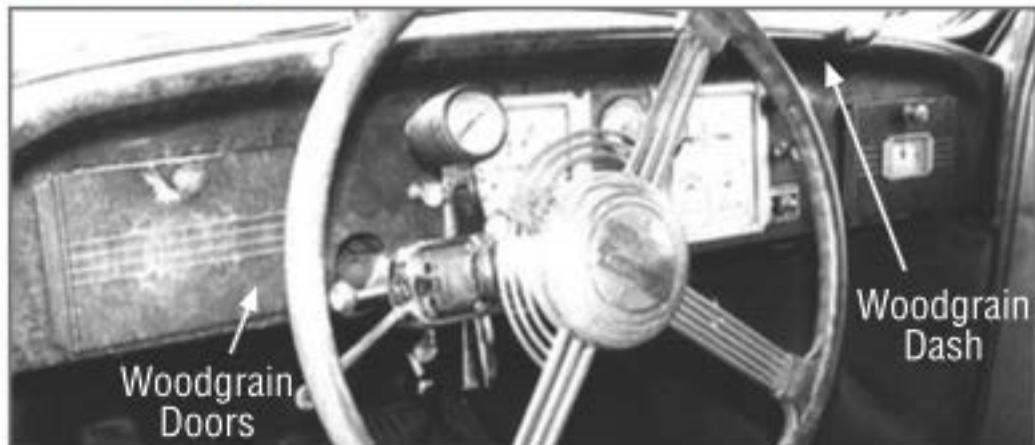
Dashboards on the S-2 DeSoto, were painted a single color or woodgrained all over. The window trim and rear seat grab bar as well are woodgrained. There are also some trim pieces in each door panel and on the back of the front seat that are woodgrained.

The sales brochure for the 1936 DeSoto S-2 (Airflow III) shows the dash to be painted in the same color as the steering column with only the glove box doors and the center ash tray woodgrained.

But the sales brochure does not tell all of the story. Nearly all of the S-2s that **Jim Lightfoot** has seen, including his coupe have the entire dash woodgrained.
