Let's talk mufflers and tailpipes...

Fan assemblies...the same for all Airflows except the CW

Switching to the Airflow Aluminum Cylinder Head

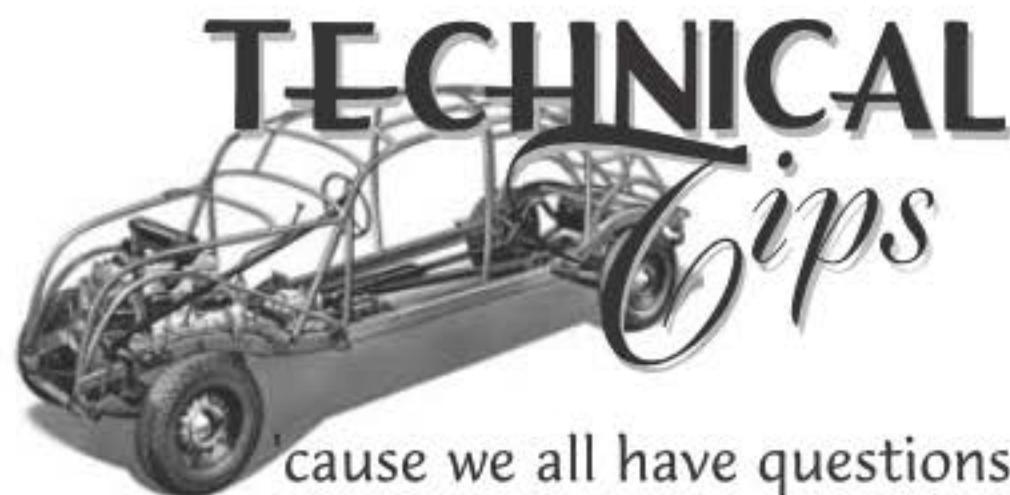
The fan drive plate is vulcanized in rubber to the fan blade assembly (note some decay occurring in the rubber). It is this rubber that decays over time and the fan can come adrift with disastrous results

There are two holes where the fan hub has a location groove stamped into it.

These two holes are at different centreline spacings than the remaining four holes. This means that the fan will ONLY fit onto the crankshaft hub in one spot and if I remember correctly the location groove lines up with top dead centre (TDC) on the impulse neutralizer hub.

The fan assembly on the S-2 is the same as that which was used on the SE and SG Airflow DeSoto.

I also can now confirm that the fan off the Chrysler Airflow is the same diameter across the blades at 20" as is the fan on the S-2. Furthermore the hub where the fan bolts on is the same part number on all so this means that the fans on ALL Airflows are interchangeable with each other.
