# TECHNICAL

### Solving a Hinge Pin Dilemma

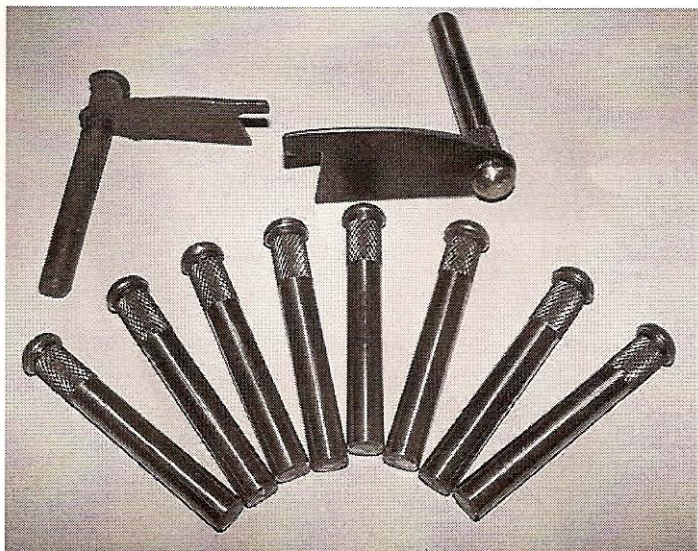
I solved my hinge pin dilemma for our '36 C-9 Coupe by making my own, see attached photos. As my hinge pins and bores in the door hinges were extremely worn I opened up the bores from 11/32" to 3/8" using an adjustable parallel reamer and sourced a number of suitable high tensile 3/8" 5/16" UNC Hexagon Socket Shoulder Screws @ \$6.00 each. These screws are supplied surface ground to 3/8" diameter and are perfect for the job. I then ground the socket heads to a convex shape to mimic the original head of the hinge pins and filled the small hexagonal hole with silver solder. The next step was to knurl the end closest to the dome head and finally after cutting them to length using a .040" cutting blade in a small grinder you see the end result in the attached photos.

Incidentally I found that the prime cause of accelerated hinge pin wear is when the hinge bores are not in alignment on both the body and the doors. This was particularly evident on our C-9 coupe as the coupe has 3 hinges on each door versus the two on a sedan door.
