These three sketches detail replacement of the wooden roof pieces on a 1934 DeSoto Airflow SE Coupe. Generally, the dimensions of the original parts are shown; if I used a different dimension or part it is noted in parenthesis.

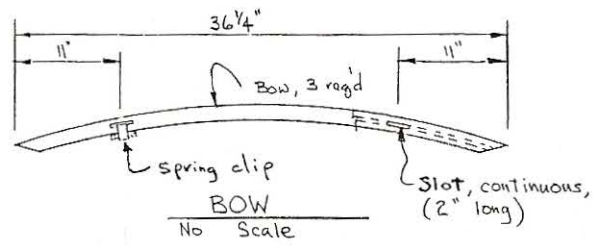
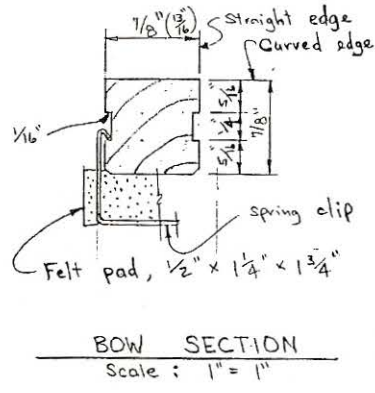
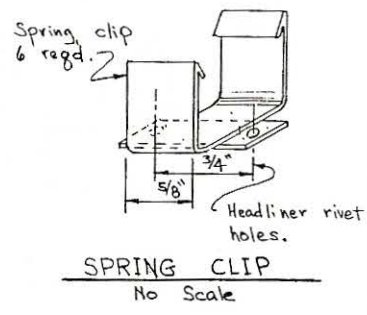
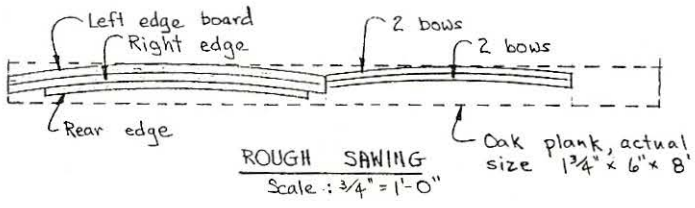
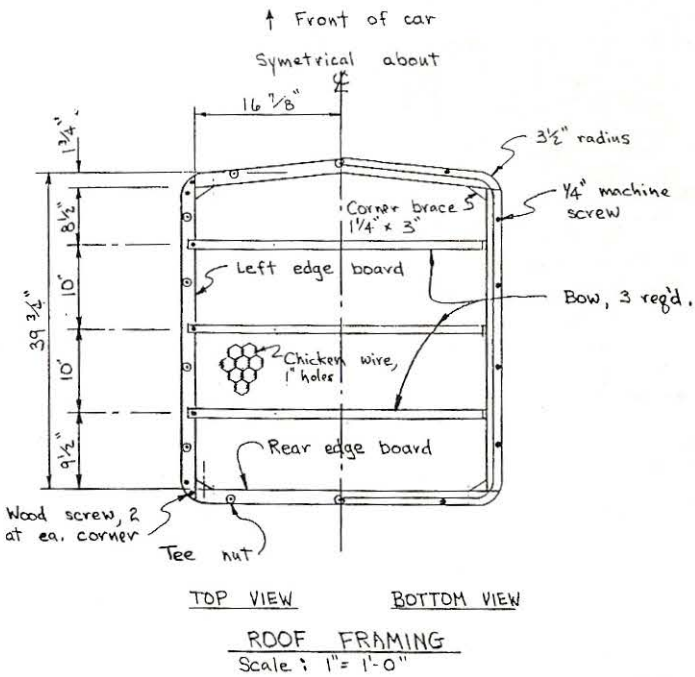
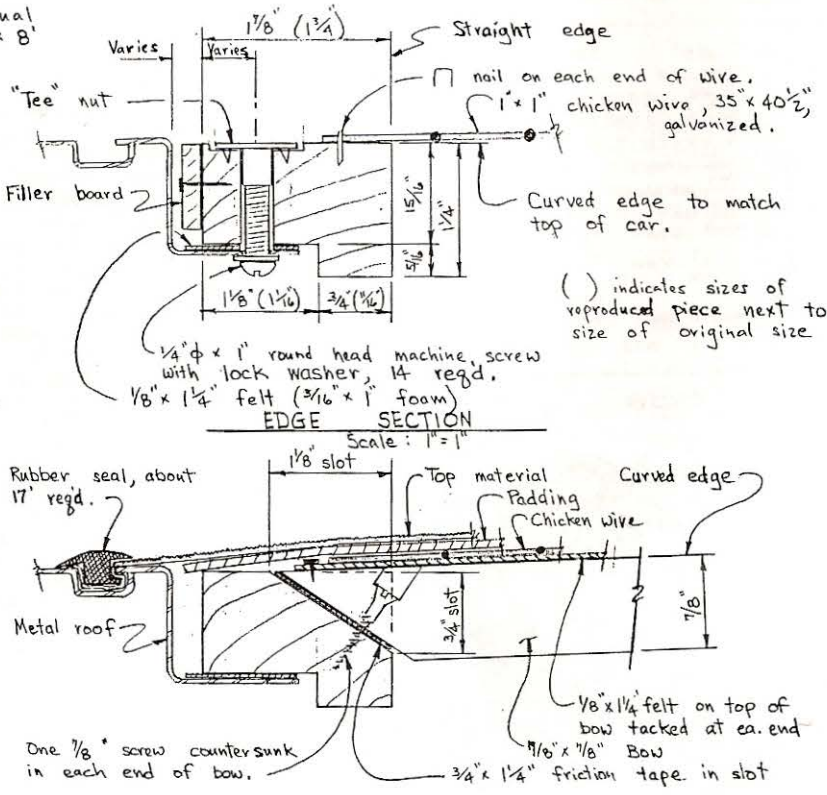
I believe the original roof frame and bows were fabricated and then assembled on a jig off of the automobile. The chicken wire was nailed on while the wood pieces were still in the jig. The assembly was then lifted onto the car and attached with tee nuts and 1/4" machine screws. Padding was placed over the chicken wire, the roof fabric was laid down and the seal rubber was pushed into its groove to lock the fabric and concurrently produce a water tight top.

My Airflow had a hardboard headliner which was riveted to six clips. These clips allowed the headliner to be snapped into place on the roof bows. The radio antenna wire is soldered to the chicken wire near the right front corner. The wire travels through a hole in the roof edge and then down the right "A" post to the radio.

EDITOR'S NOTE: If you can find a source of Ash wood instead of Oak wood, you'll find it much stronger, less subject to warpage and generally superior in all aspects to Oak. Ash looks very similar to Oak and still responds to tools the way oak does.
