Maybe one of these latest tips will help in the restoration of your prize Airflow

Airflow NEWSLETTER

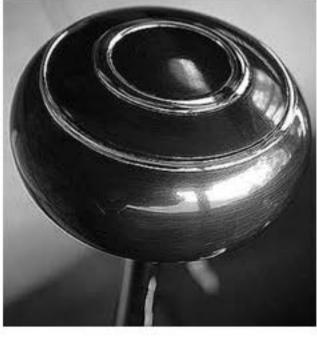
Old gear shift knob

New gear shift knob...what a difference!

I've recently been working with John Spinks from Australia on restoring a small pair of rings out of a '36 Airflow gear shift knob that came from a car in Australia. John sent me the rings to get them rechromed in the states. He's done amazing work by making a new knob and restoring the rings and gear shift to their original brilliance. In one piece of correspondence, he imagined something of a timeline, tracing the path taken over the years by these often ignored and invisible elements of the automobile. I thought other Airflow enthusiasts might be interested to read these musings from one of their fellows across the globe.

John has mentioned to me that he might be interested in making more of them if there was an interest. Call me or E-mail me if you want to be considered (no commitment at this time) for a new knob as pictured. Depending on enough interest, the cost would be somewhere between \$100.00 to \$150.00US.
